Corrosion by Amine Hydrochloride

Senior Analyst and Inspector Training
Crude Units

Corrosion by Amine Hydrochlorides

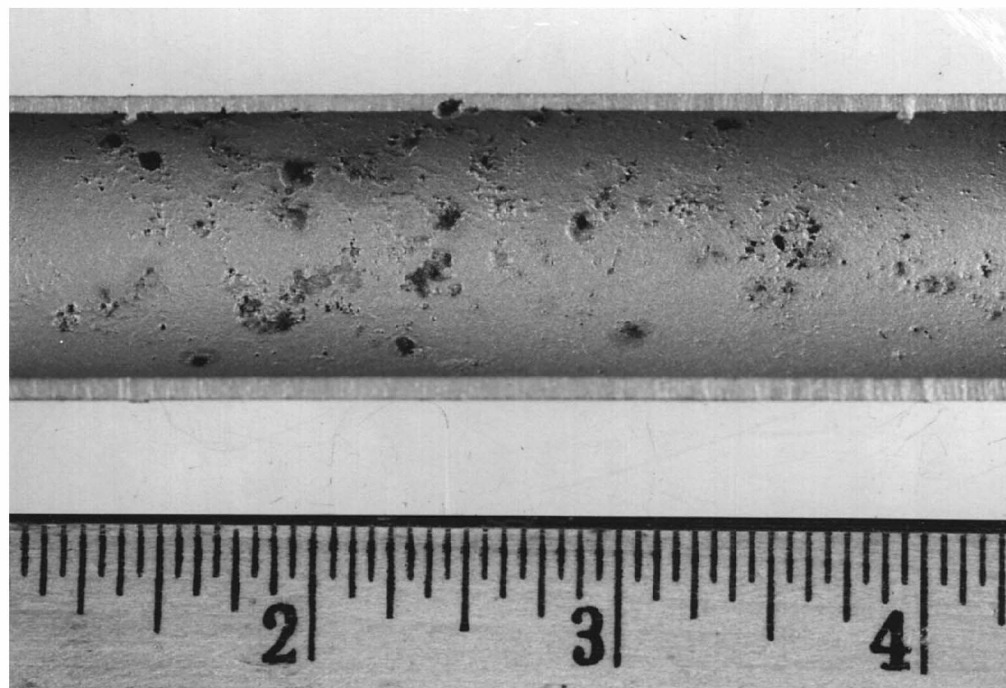
Amine Hydrochloride Corrosion of 70 Cu - 30 Ni Atmospheric Overhead Condenser Tube From Perth Amboy

- *A change in crude feed resulted in higher chlorides and more amine injection in the overhead system*

Inner surface of pitted tube after grit blasting to remove scale

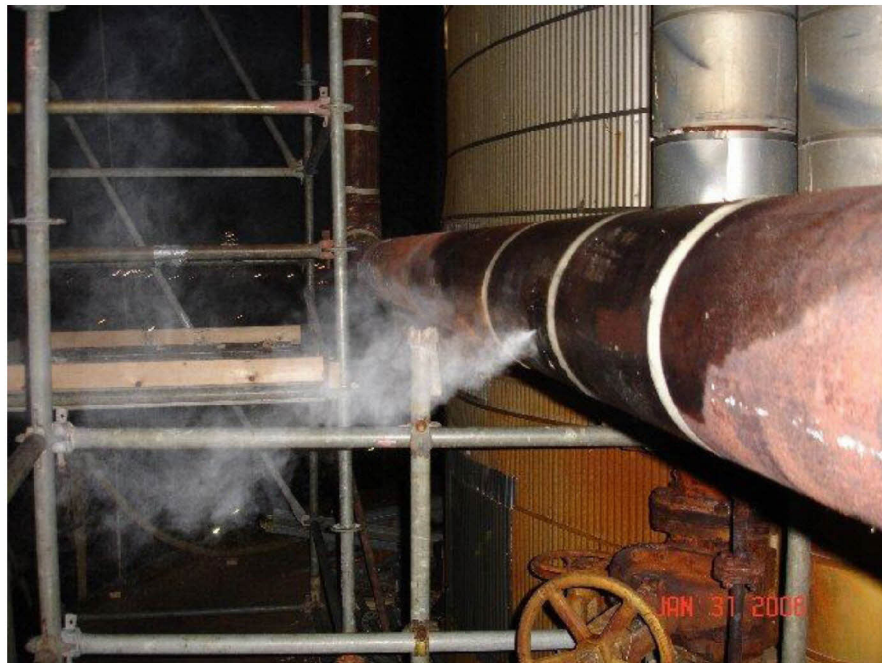
Pascagoula's 1st Sidecut Leak

- Leak occurred in 2006 in Pascagoula's 1st sidecut
- Caused by deposits and a corrosive liquid thought to be MEA-HCl, probably with some water
- Sidecut had been experiencing unusually low temperatures for a 1st sidecut system

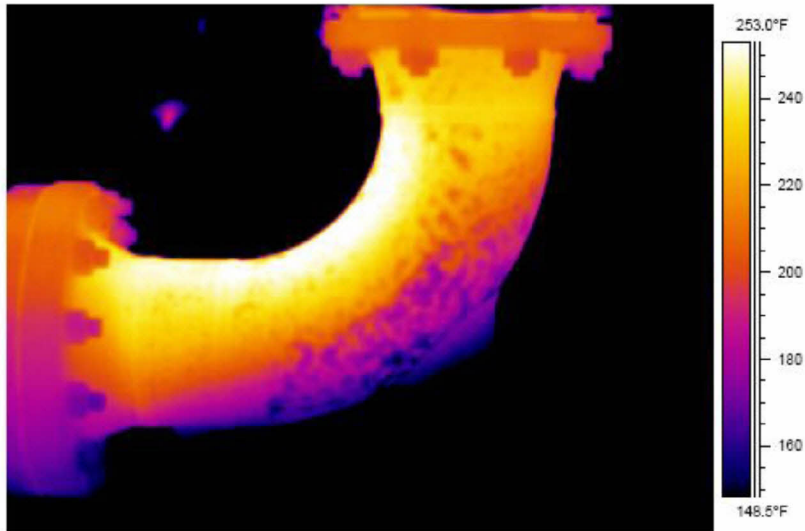
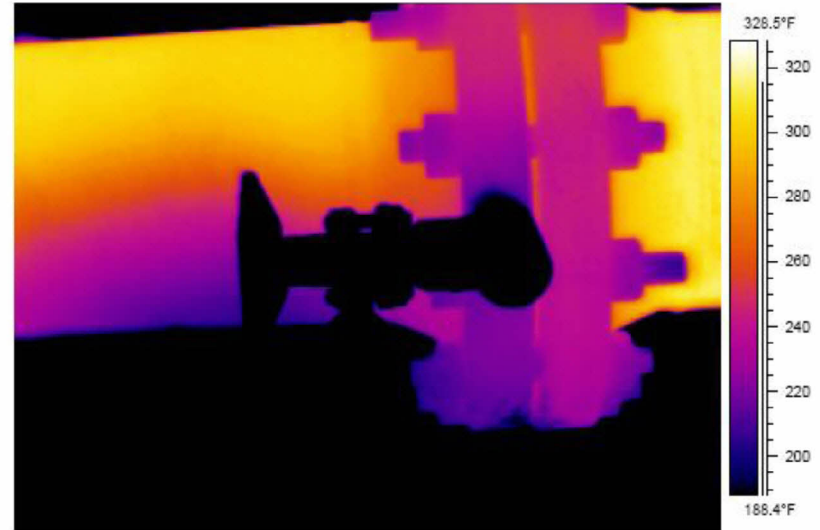
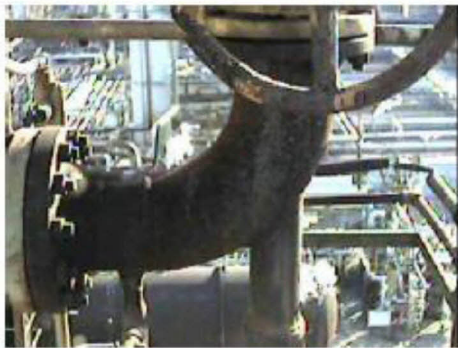
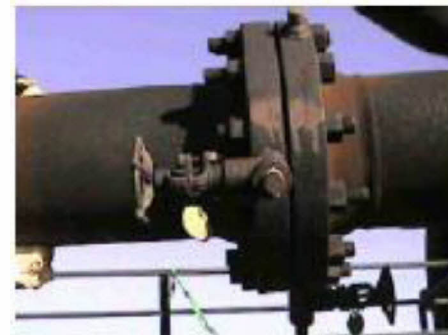
Infrared Thermography of Pascagoula's 1st Sidecut
